National Register of Historic Places Registration Form

Historic name: Ervin Homestead/Gist Bottom Historic District

Other names/site number: 24BL1546/24BL1547

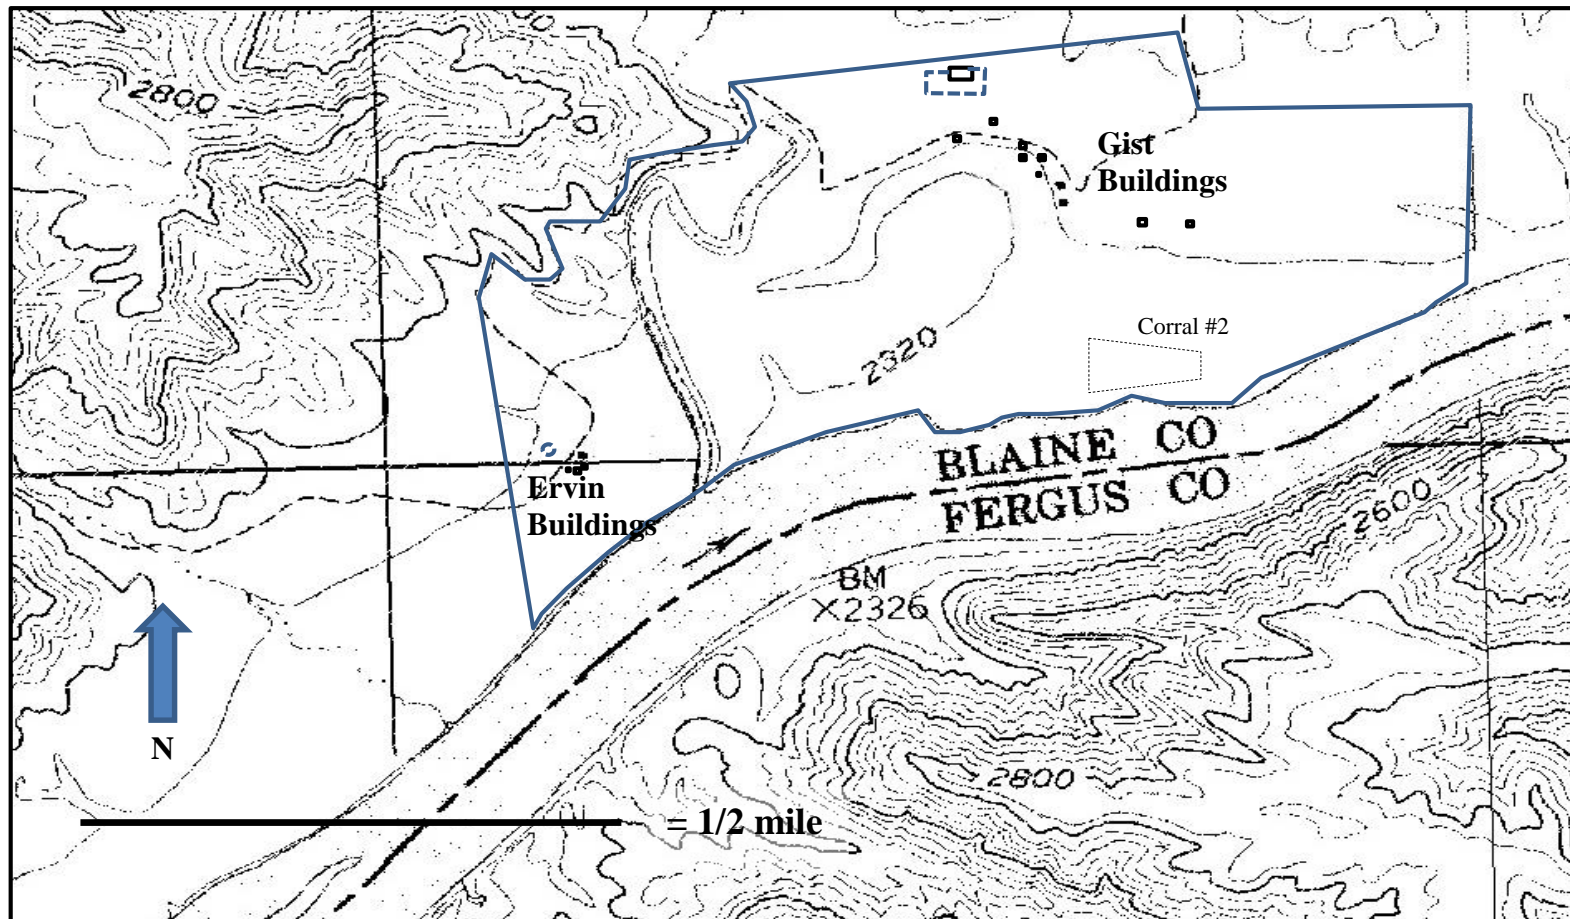
Ervin Homestead/Gist Bottom Historic District Sketch Map ■ Buildings □ Sites [] Structures

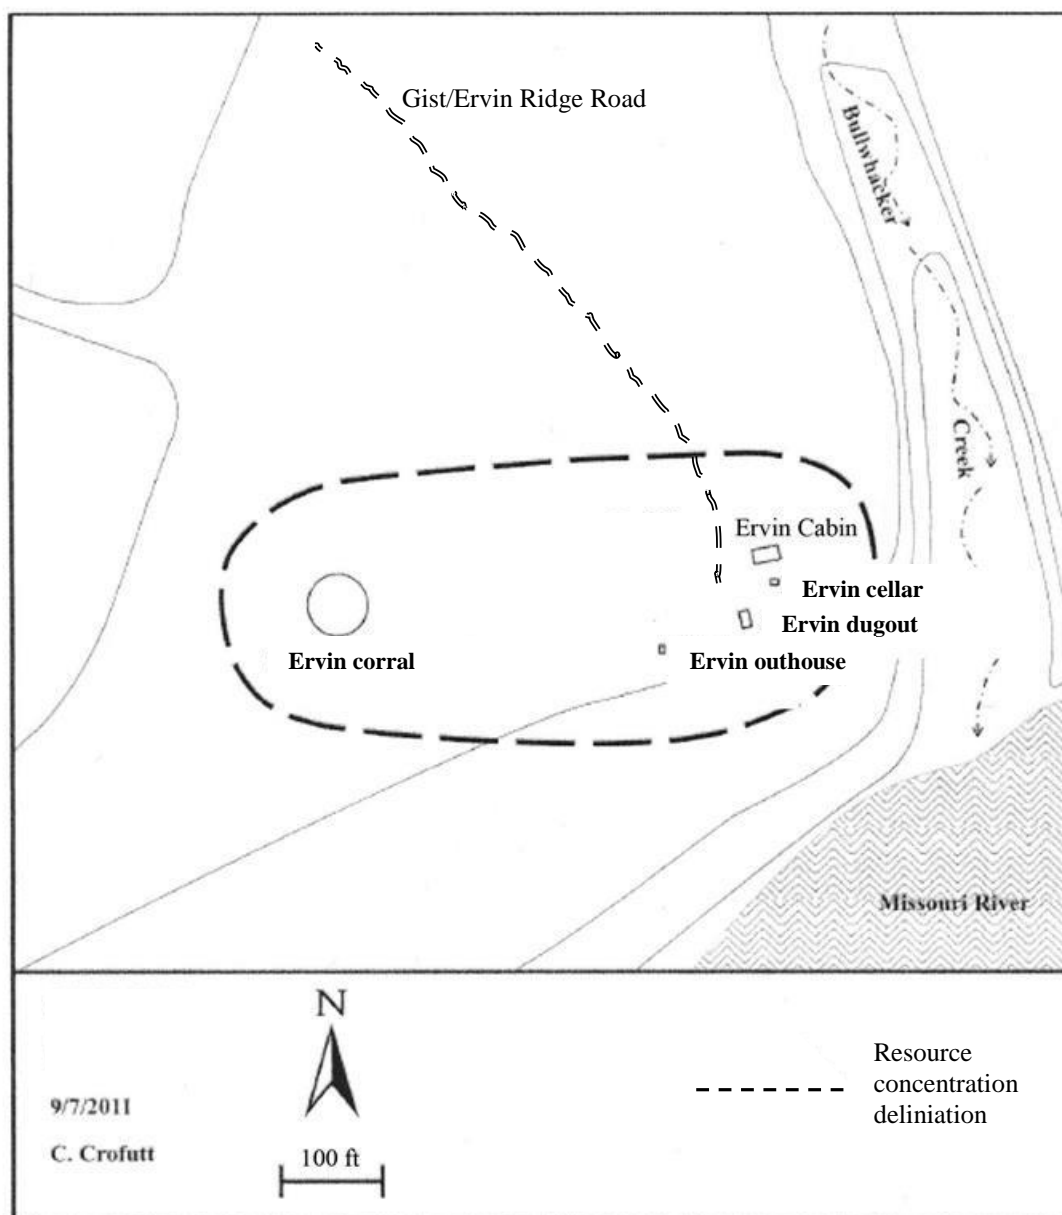
Detail of Ervin Homestead site plan²

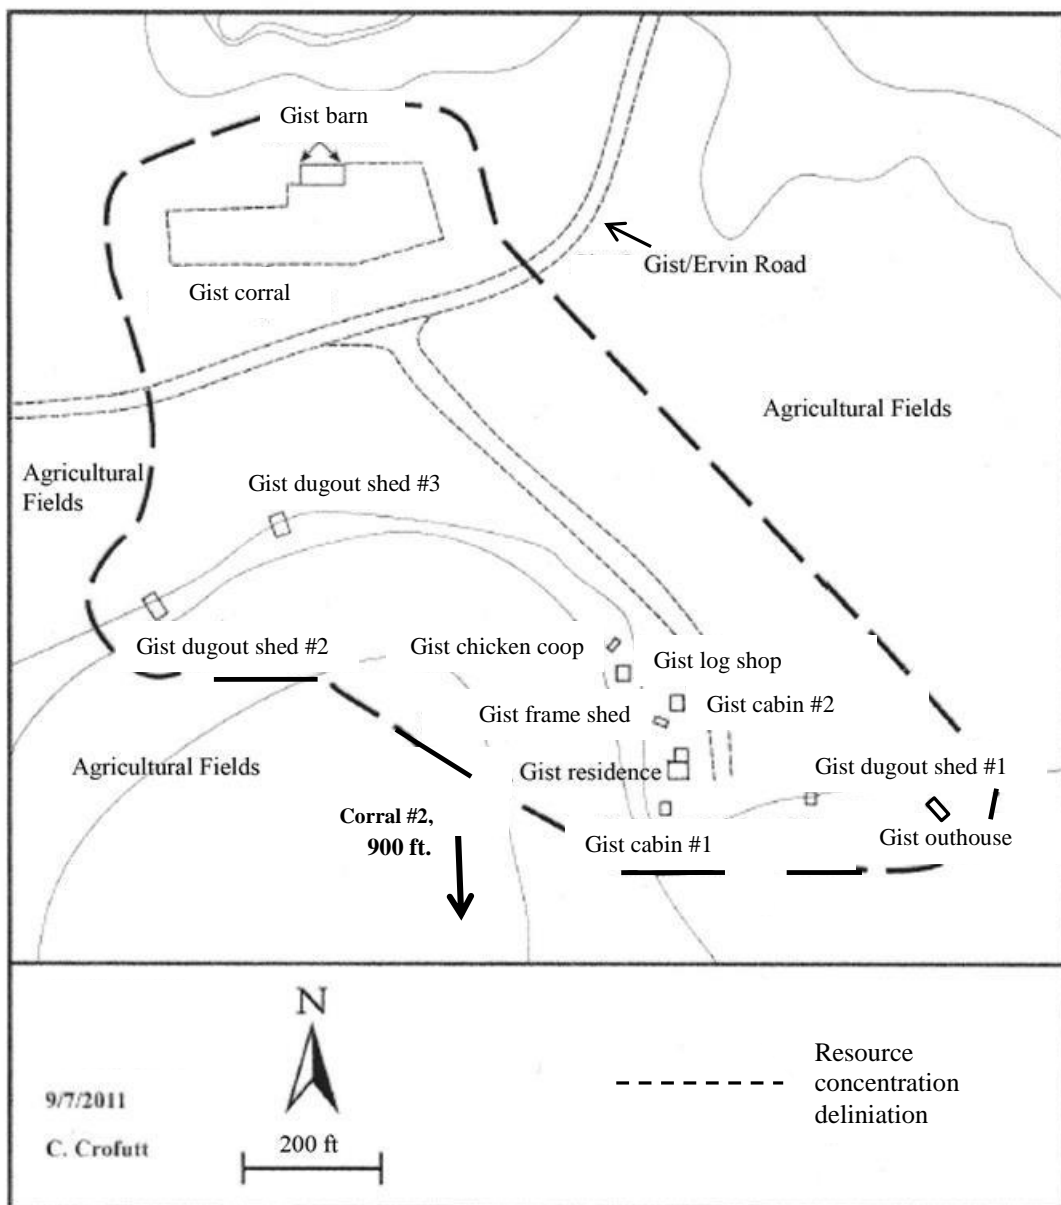
Detail of Gist Bottom Ranch site plan³

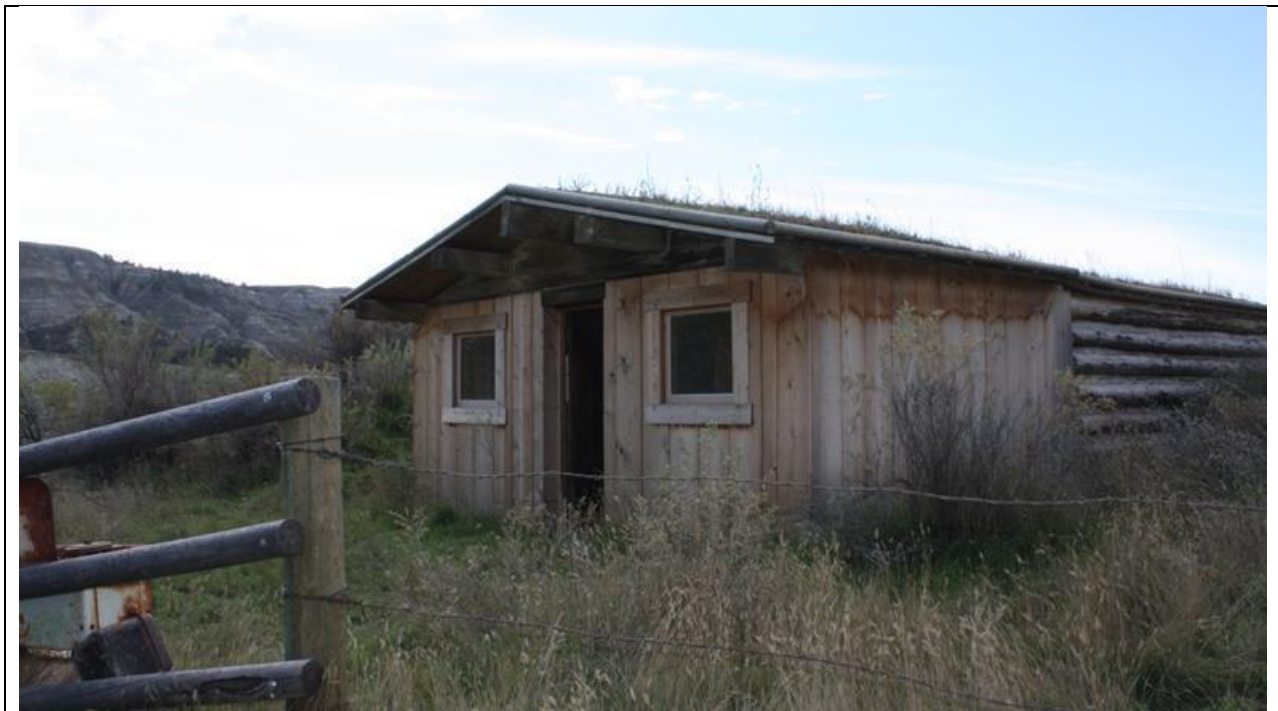
MT_Blaine County_Ervin Homestead/GistBottom_HD_0001
East and north elevations of rehabilitated Ervin Cabin. View to the southwest.

In 2008 and 2009, the BLM and Forest Service Historic Preservation Team stepped in to stabilize deterioration and prevent collapse. Structurally sound logs were retained and new logs were harvested from ponderosa pine groves and hand peeled. The subsurface logs on the three sides of the dugout wing were replaced, leaving the interior log wall and the upper courses intact.

Later work included reburying the west wall, reroofing, and rehabilitating the east addition. During reroofing, two original log purlins were retained on the west and new replica logs added where needed then covered with 2-inch x 12-inch wood planks and local dirt to a depth of 5 inches. A square, tin-lined stovepipe hole was in the NW corner of the roof. To prevent roof leaks, the stovepipe opening was not reintroduced.

Rehabilitation of the east addition included sill log replacement, installation of new floor boards and replica window sash and trim. The interior cabinet, rafters, original interior door on the west wall, and the front door remain intact.

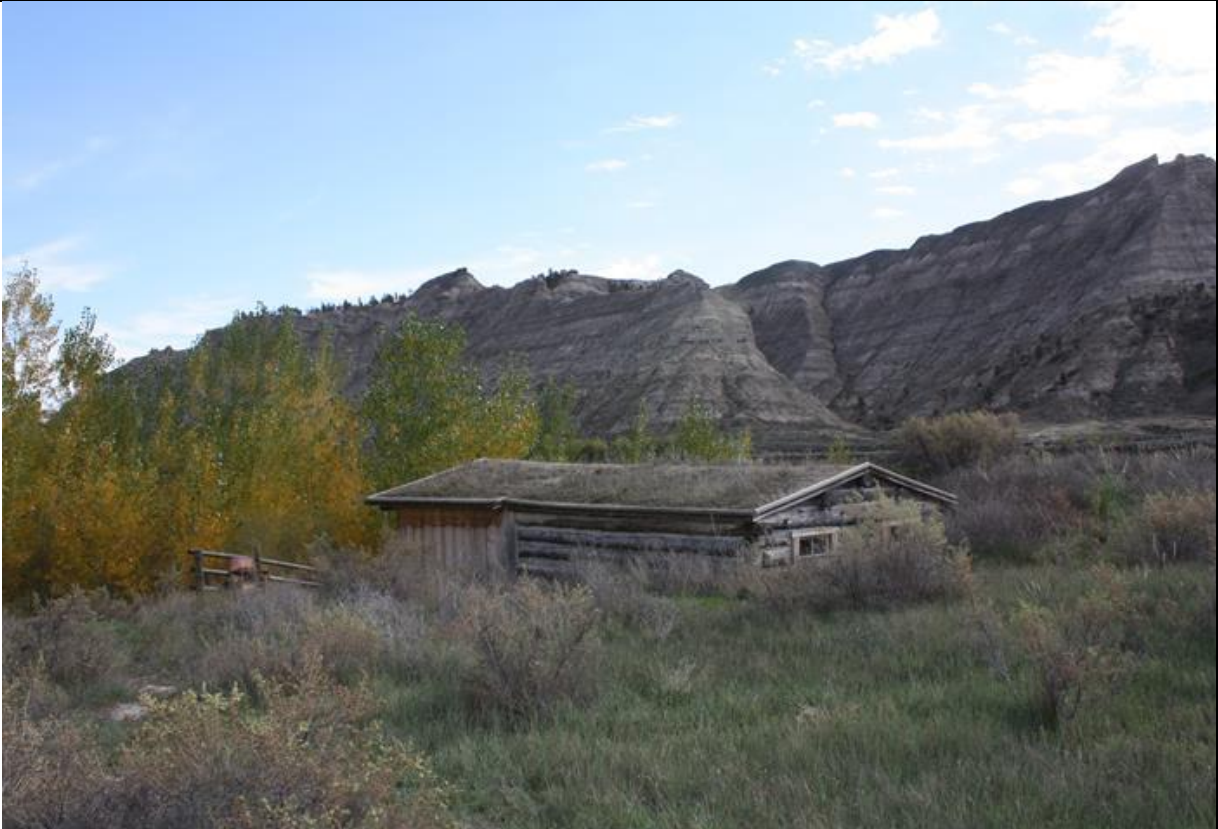
MT_Blaine County_Ervin Homestead/GistBottom_HD_0002
North and west elevations of Ervin Cabin, view to the southeast.

The foundation consists of 6-inch square ground contact wood beams and the far west end of the cabin is partially buried or dugout into the hillside. Unpainted square-notched log walls comprise the western two-thirds of the cabin. Split logs serve as chinking. The post and beam addition on the east is clad with unpainted vertical 1-inch by 12-inch replacement wood plank siding. The front-gable roof covers both the frame and log portions of the building. A 3-inch by 12-inch timber ridge beam and two 8-inch square timber joists support the eastern portion of the building. The ridge and joists are exposed on the east under an 18-inch overhang. A 10-inch-wide log

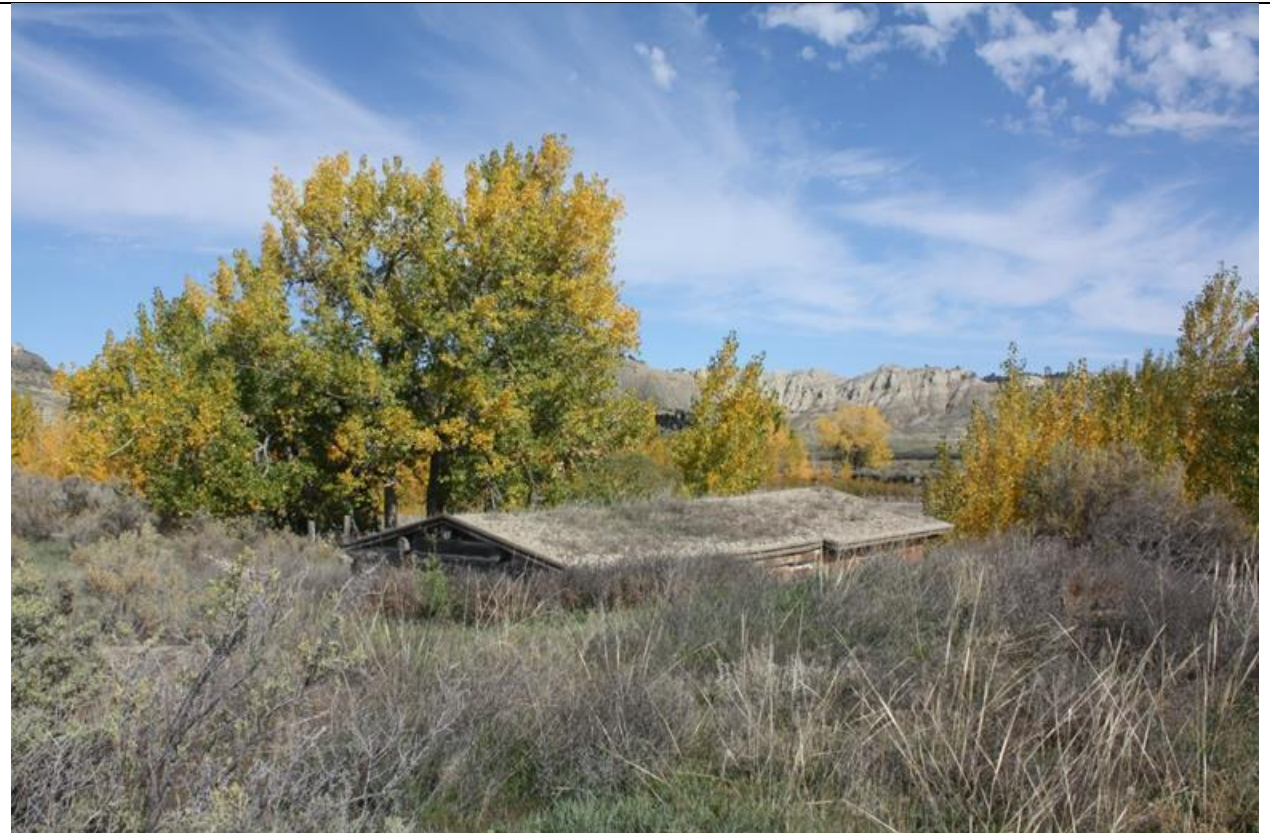
MT_Blaine County_Ervin Homestead/GistBottom_HD_0003
West and south elevations of Ervin Cabin, view to the northeast.

The harsh environment, deferred maintenance, and an ice jam on the Missouri River and Bullwacker Creek threatened to destroy the Ervin Cabin in the mid-2000s. The south wall of the east addition collapsed and the entire building started to shift. Also, the sod roof was failing due to nonhistoric corrugated metal sheathing and the west log wall was badly deteriorated from its location buried in the hillside.

There was originally a door on the dugout wall that led out the back of the west wall. Since it was buried, the door may have led to a small root cellar or cold storage room. The decision was made not to replace the cellar and the door was converted to a window. Window openings were measured, and all windows were rebuilt to replicate the originals.

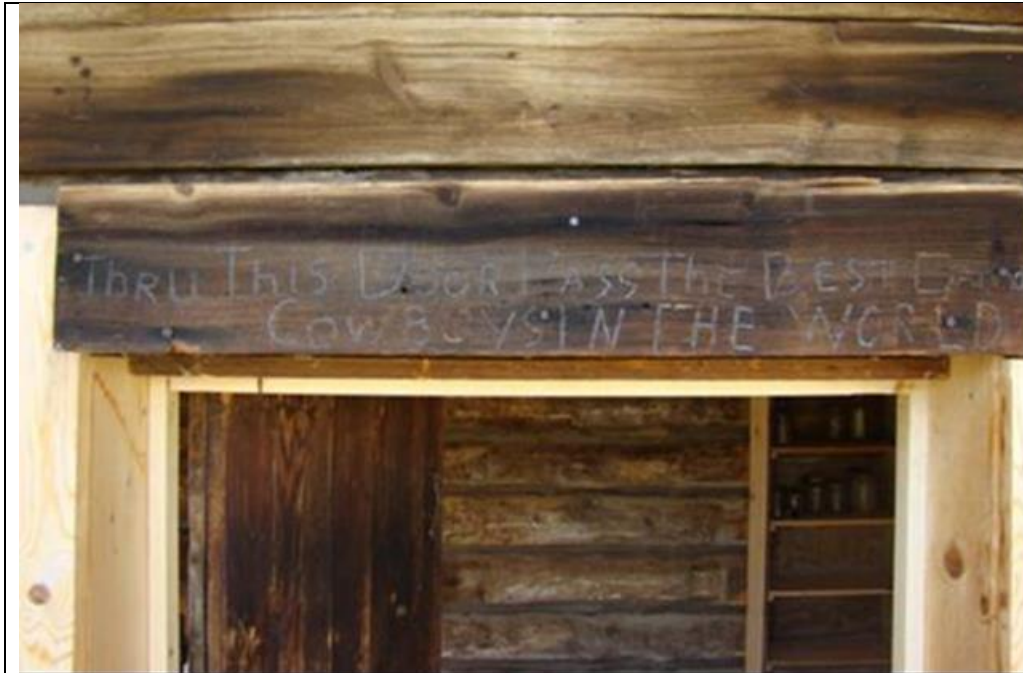
East elevation entrance door of Ervin Cabin with inscribed sign above. "Thru this Door Pass The Best Dam'd Cowboys in the World." View to the east.

The east or front façade wall consists of a central entrance door flanked by identical 24-inch-square, fixed wood and glass windows with 1-inch by 4-inch trim. The door measures 31 inches by 6 feet and consists of three Z-braced vertical planks. Above the door, a 1-inch by 4-inch wood plank header displays the wood-burned inscription, "Thru this door pass the best dam'd cowboys in the world."

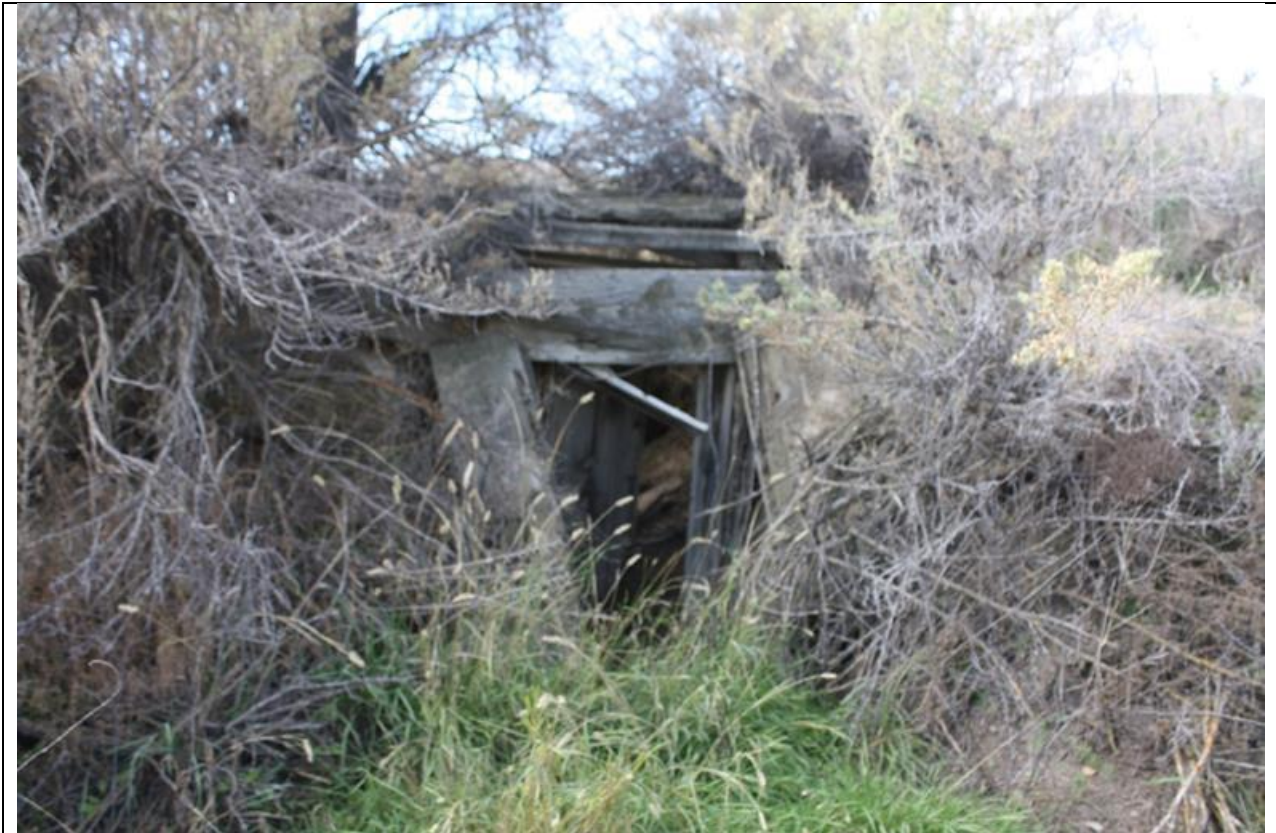
MT_Blaine County_Ervin Homestead/GistBottom_HD_0009
Ervin Cellar, east elevation. View to the west.

Ervin Cellar (one contributing building): Directly to the south of the Ervin Cabin lies a 6-foot by 8-foot partially collapsed cellar constructed of log and milled timbers. The cellar is badly deteriorated, however, there is evidence of a vertical plank door, log ridge beam and split log roof sheathing covered with dirt. It is not known when Ervin built the cellar, although it was likely constructed shortly after spring 1911. Ervin does not list a cellar on the property in his Homestead Entry Final Proof; however, he does list “sheds” (Ervin Case File).

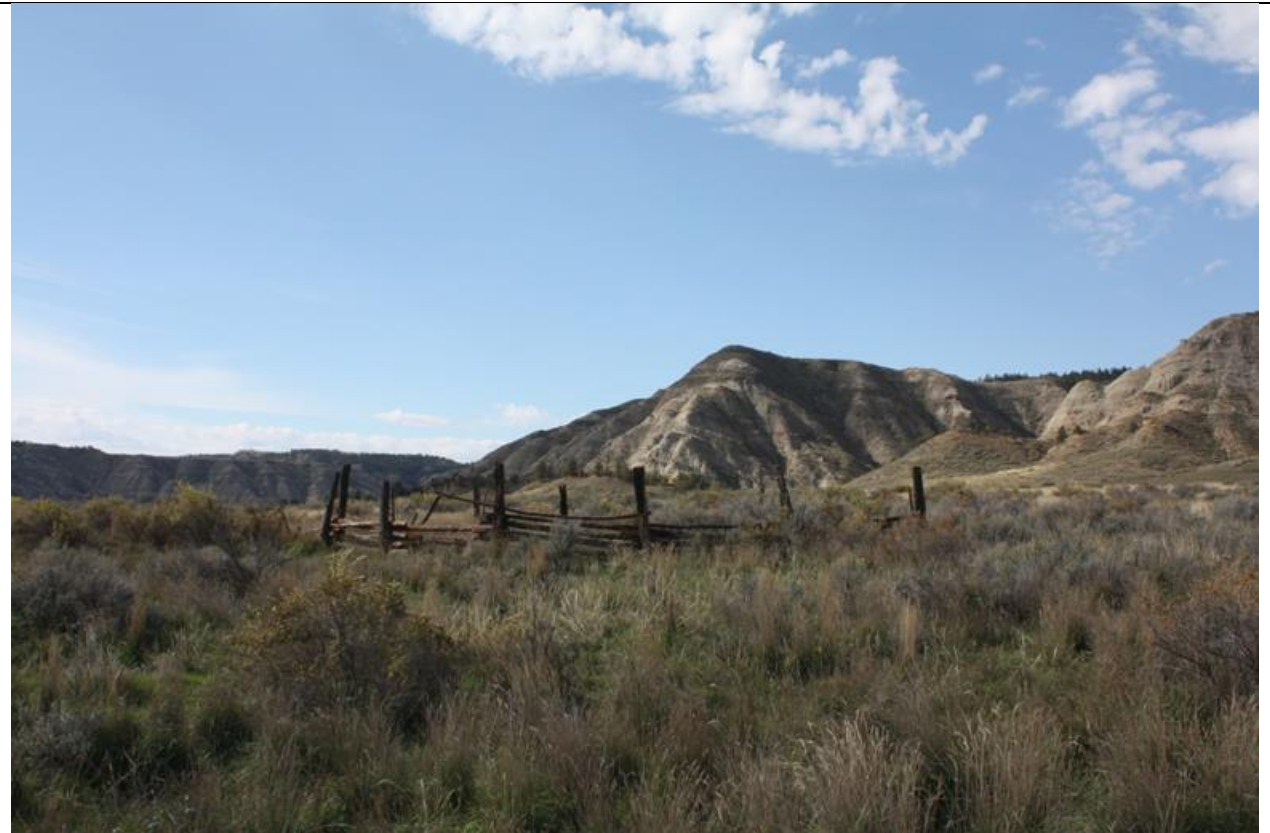
MT_Blaine County_Ervin Homestead/GistBottom_HD_0013
Ervin Corral. View looking west.

Ervin Corral (one contributing structure): A deteriorated circular log and pole corral is located about 350 feet west of the buildings. Eighteen posts spaced approximately 10 feet apart

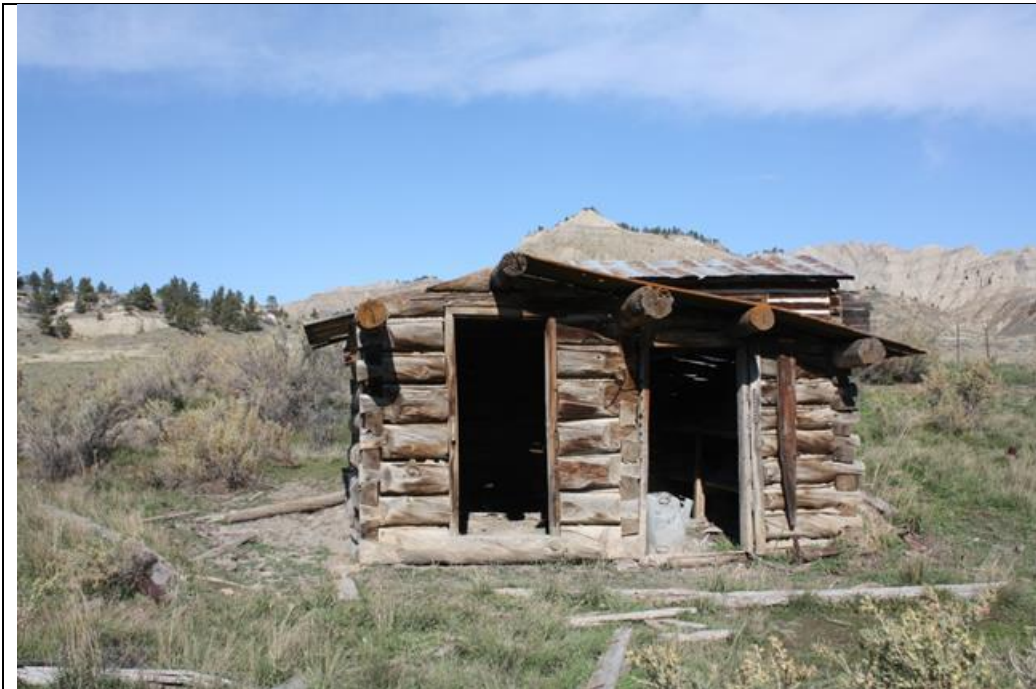
MT_Blaine County_Ervin Homestead/GistBottom_HD_0016
Gist Cabin #1. South elevation. View to the north.

Gist Cabin #1 (one contributing building): This one-story rectangular building is the southernmost building in the Gist cluster of buildings. The building is abandoned and in fair condition. The date of construction is likely spring 1948 when the Gist family began moving other buildings to the property and expanding their cattle operation near the river (Gist 1995).

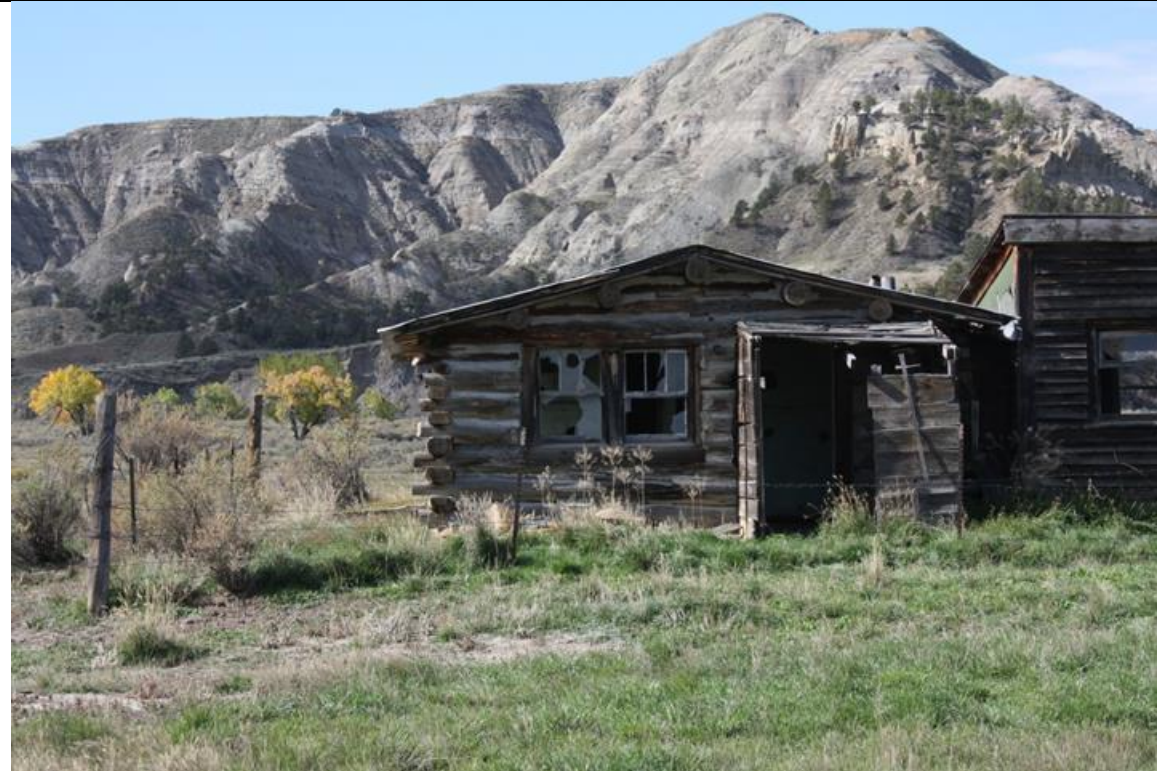
MT_Blaine County_Ervin Homestead/GistBottom_HD_0024
Gist Residence. Detail of south wing. East elevation. View to the west.

The south wing measures 18 feet by 21 feet and rests on a stone and concrete foundation. The log walls are lapped at the corners and chinked with a mixture of concrete and grass. The chinking is in fair condition.

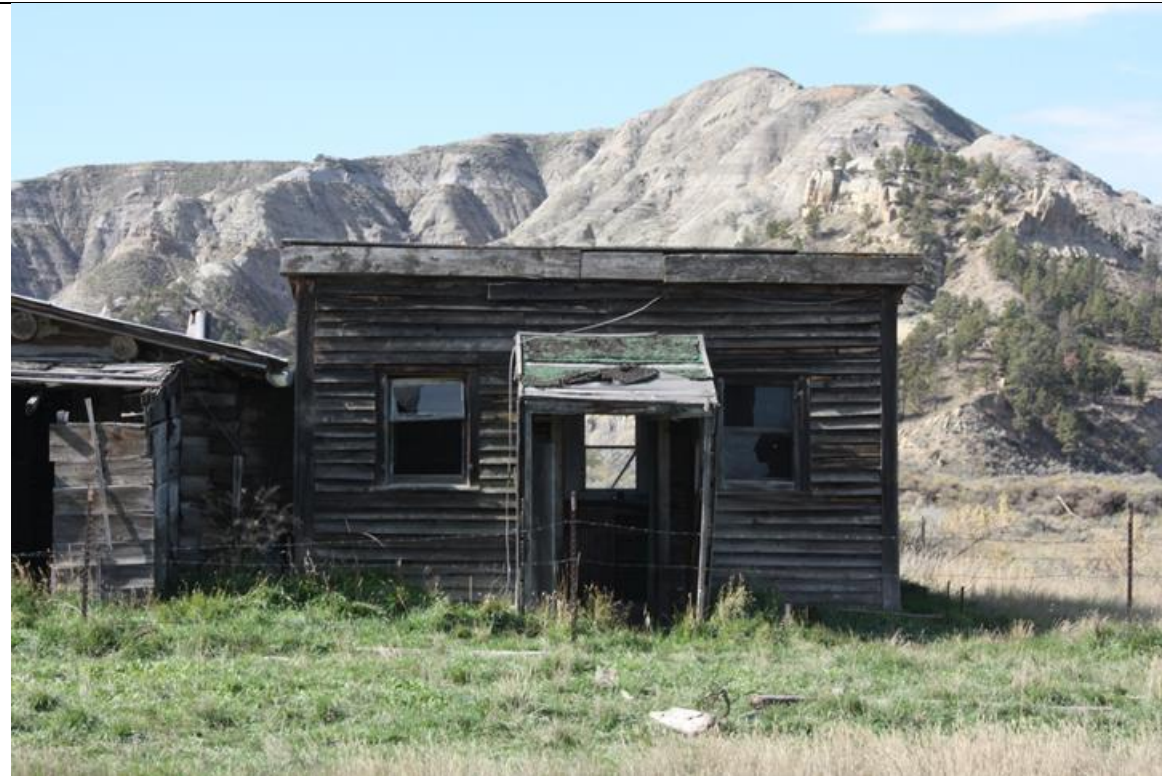
MT_Blaine County_Ervin Homestead/GistBottom_HD_0025
Gist Residence. Detail of north wing. East elevation. View to the west.

The north wing measures 13 feet by 17 feet and no foundation is visible. The east and north walls are clad with unpainted wood shiplap siding with 6-inch-wide wood corner boards. The west and south walls are clad with 1-inch-thick horizontal wood planks covered with the remnants of green asphalt roll roofing. A wood frame vestibule is centered on the east elevation around the entrance opening (no door remains). The vestibule is constructed of 2-inch by 4-inch wood framing with a shed roof. The exterior sidewalls and roof of the vestibule are covered with 1-inch-thick wood boards and clad weathered green asphalt roll roofing. Inside the vestibule on the south wall is a wood shelf, and a square window opening on the north.

Fenestration on the north wing includes two 1-over-1 double-hung sash on each side of the entrance on the east elevation. The west elevation has a central paired 1-over-1 double-hung sash. Most of the glass is missing from all the sashes.

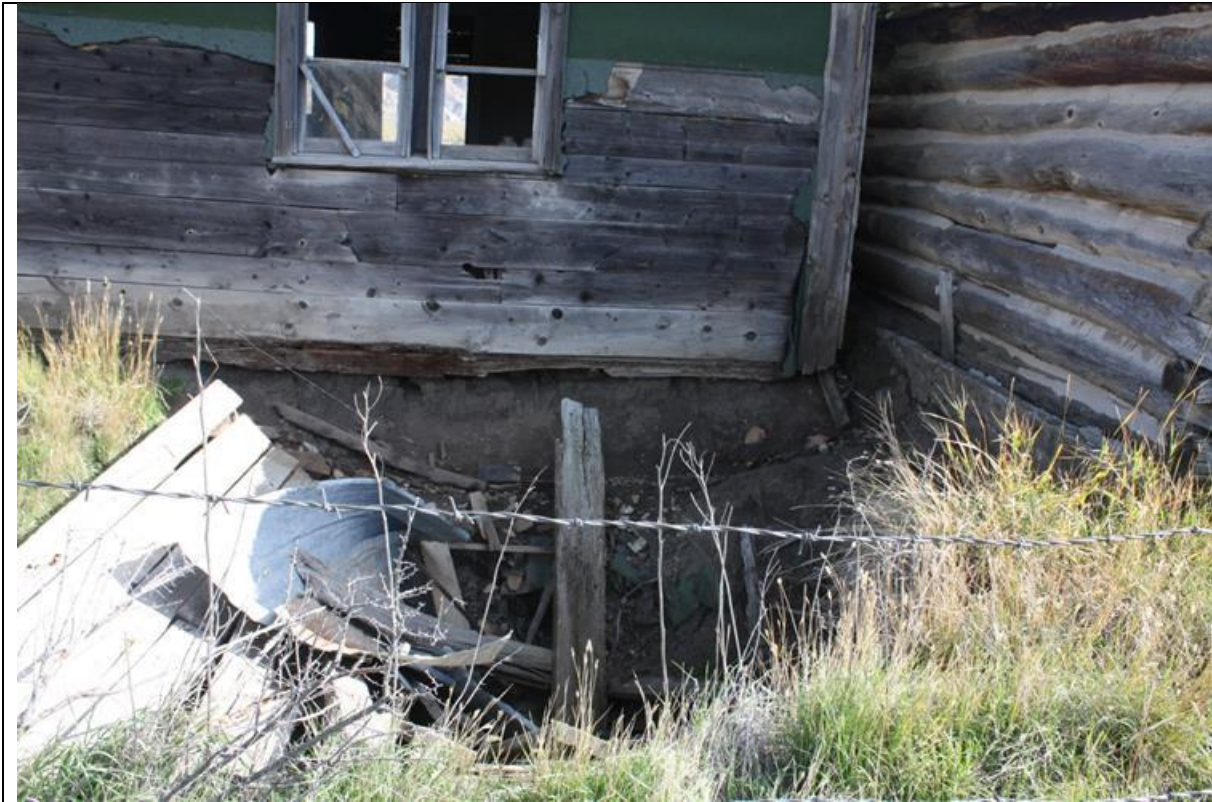
MT_Blaine County_Ervin Homestead/GistBottom_HD_0028
Gist Residence. Detail of collapsed well, west elevation. View to the east.

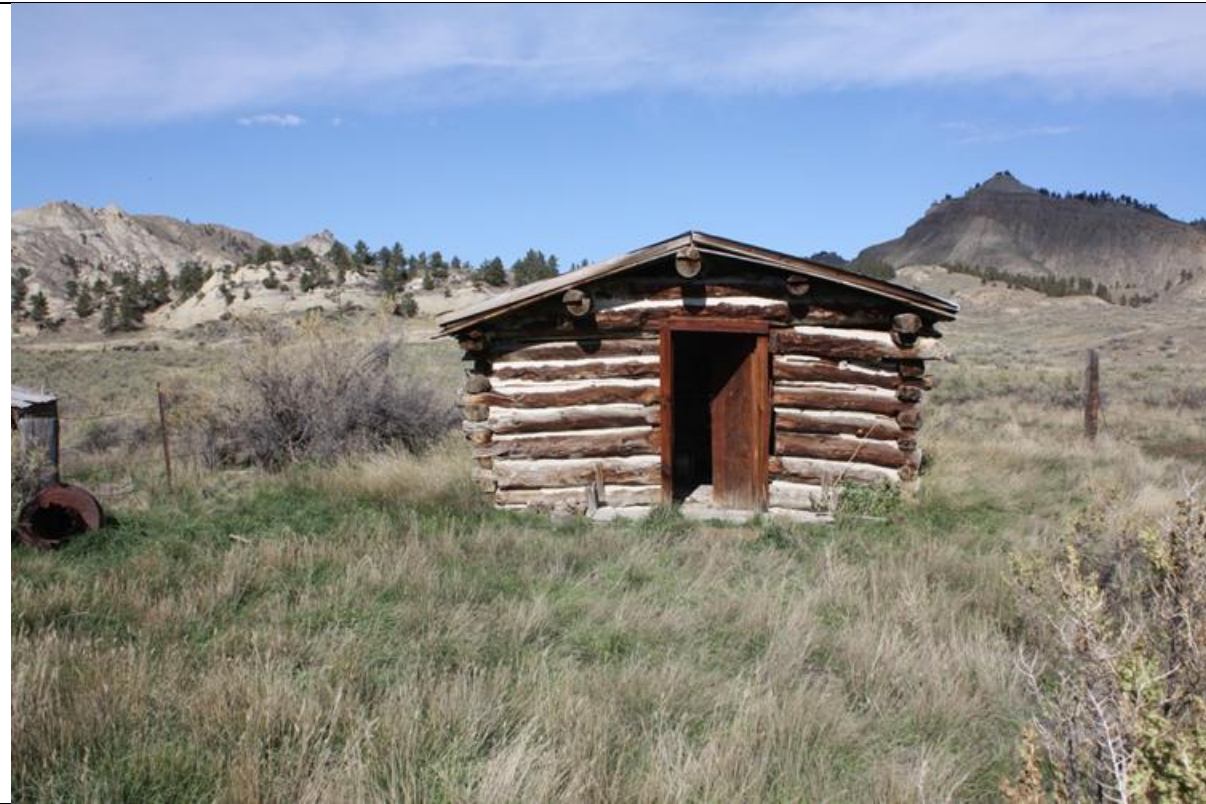
MT_Blaine County_Ervin Homestead/GistBottom_HD_0029
Gist Cabin #2. South elevation. View to the north.

Gist Cabin #2 (one contributing building): Another one-story log cabin is located approximately 25 feet north of the Gist Residence. The building was used for a bunkhouse. It is now abandoned and in fair condition. The Gist brothers and father, Leo Gist, likely built the building in the late 1940s or early 1950s using local timbers.

The roof structure consists of six log purlins that overhang 12 inches on the north and south. The logs are covered with 1-inch by 12-inch wood plank sheathing and the soffit and rake board are finished with 6-inch milled wood boards that form a tray for what was a dirt or sod roof. The sod roof is now covered with corrugated sheet metal; however, one or two panels are missing on the east side and show evidence of the historic sod roof below.

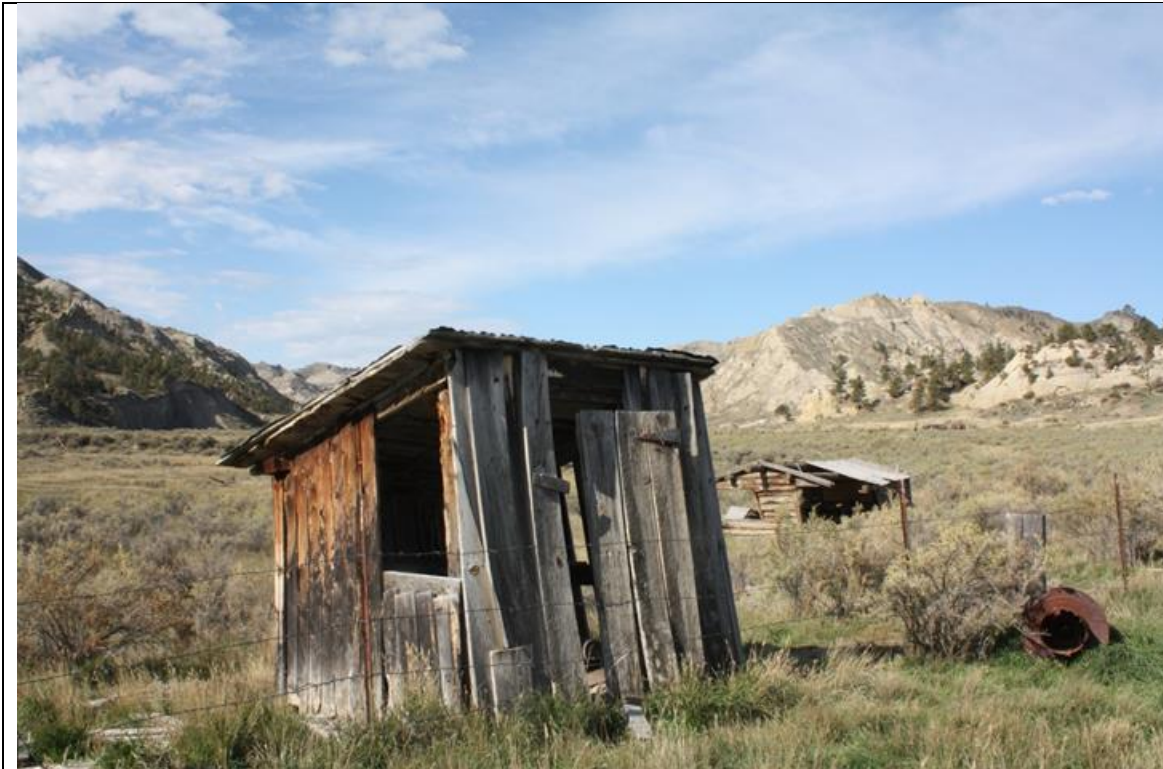
MT_Blaine County_Ervin Homestead/GistBottom_HD_0033
Gist Frame Shed. South and east elevation. View to the northwest.

Gist Frame Shed (one contributing building): A one-story wood frame shed is located approximately 12 feet southwest of Gist Cabin #2. The shed is leaning to the west and is in poor condition. The build date and builder remain unknown, though the building definitely appears historic.

It measures approximately 5 feet by 7 feet and appears to lack a foundation. The walls are sided with 1-inch by 12-inch vertical wood planks. There is a vertical plank entrance door on the east elevation that rests up against the door opening. Boards on the east side of the south elevation are cut away to form a window opening. The shed roof slopes down to the west and is clad with 1-inch by 12-inch wood boards that overhang about 12 inches on the north and south elevations and about 6 inches on the east and west elevations. The boards are clad with corrugated sheet metal.

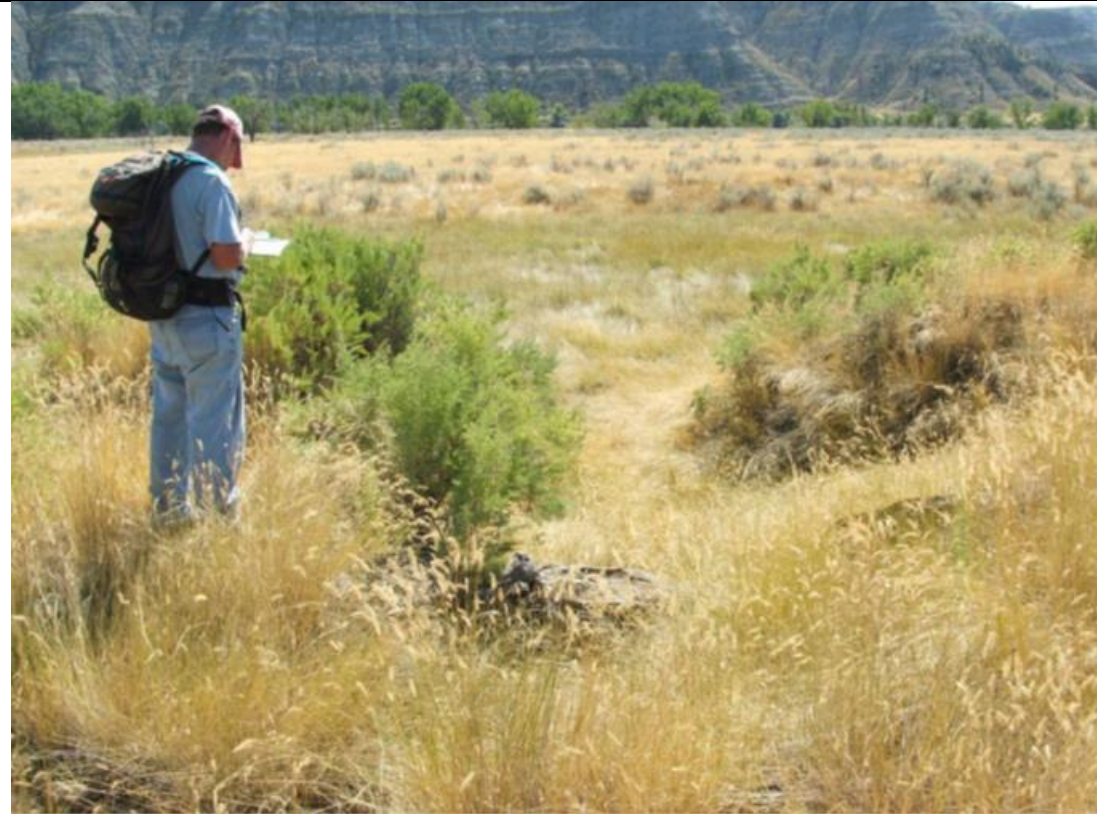
MT_Blaine County_Ervin Homestead/GistBottom_HD_0050
Gist Dugout Shed #3. View to the west. Photo by Cris Crofutt, Aaberg Cultural 2011.

Dugout Shed #3 (one contributing site): The feature, like Dugout Shed #2, consists of the remains of a shed dug into the north bank of an old channel. It lies northwest of the main building cluster. The south end of the feature is much narrower than the north end. One very large timber (broken in two pieces) lies at the north end. The north end has eroded and is collapsed, likely due to livestock and/or wildlife actions. No vertical timbers are in place and only three smaller timbers are present inside the dugout. These small timbers are likely collapsed supports. The timbers lie directly on the earthen berm. A small piece of barbed wire is present within the dugout. A piece of farm machinery is present to the southeast, across the old channel. Heavy vegetation and sedimentation prevented accurate measurement of the feature.
